RESIDENTIAL REPORT

1234 Main St.
Washington MD 20005

09/18/2018 9:00AM

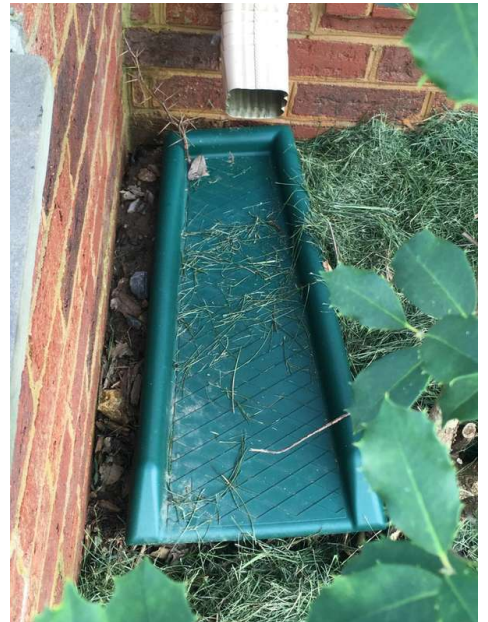
2.5.1 Roof Structure & Components

DOWNSPOUTS DRAIN NEAR HOUSE

Front left downspout drain too close to the home's foundation. Recommend an extension to drain at least 6 feet from the foundation.

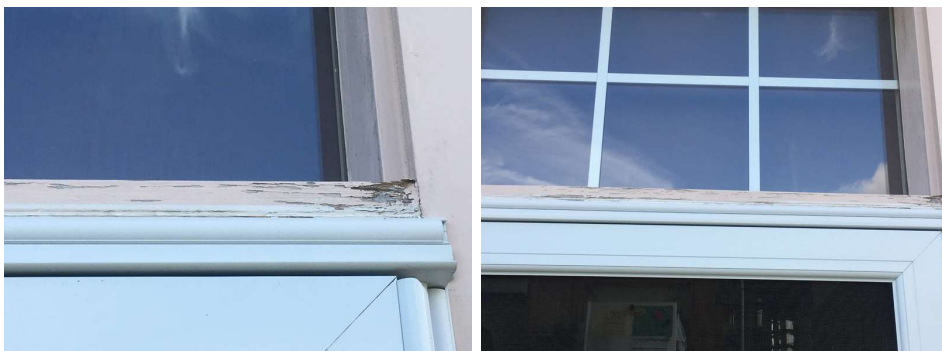
9.1.1 Siding, Flashing & Trim

PAINT NEEDED

Trim at top of main entrance in need of repainting.

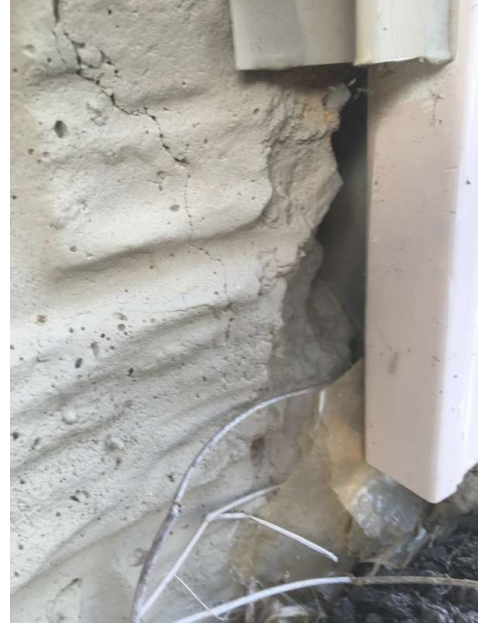
9.3.1 Garage Door

HOLE IN WALL

Hole in bottom left side of garage. Recommend sealing to prevent intrusion of pests.

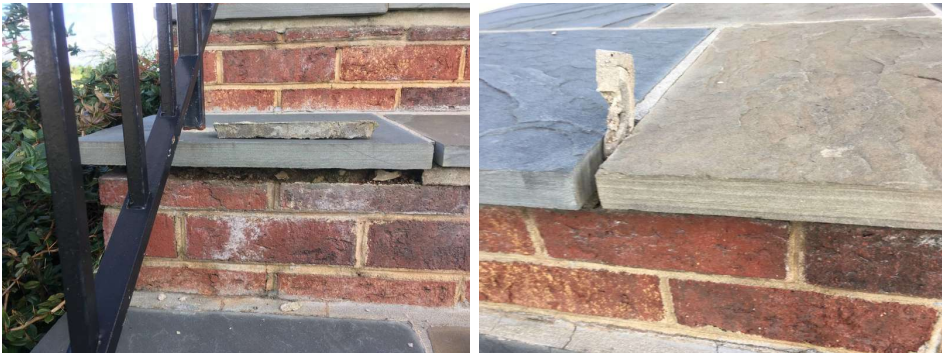
9.4.1 Decks, Balconies, Porches & Steps

STAIRS - DETERIORATED

Mortar on front stoop deteriorated. Recommend qualified concrete contractor evaluate & repair.

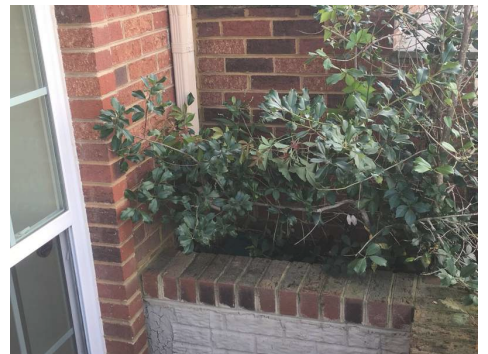
9.6.1 Vegetation, Grading, Drainage & Retaining Walls

OVER GROWN BUSHES OR SHRUBS

Shrub in front right side over grown. Recommend trimming to prevent contact with house.
